Application Of Operational Reliability Tools In The Evaluation Of Buildings

Liyeen Pérez Quiñones¹, Marietta Llanes Pérez², Alejandro López Llanusa³

The study is carried out at the Clinical Surgical Hospital "Dr. Salvador Allende", known as Quinta La Covadonga. This hospital complex was built by Spanish immigrants for the well-off segment of the population. The facilities were built within the late 1800's and the early 1900's, and although not the totality of the original buildings are in place today, some were rebuilt before 1930 [6]. The site is characterized by being made up of pavilions, which are generally differentiated depending by function, although there is architectural and construction uniformity throughout the complex, and the pavilions are considered to be of patrimonial value.

In this work, the constructive technical evaluation of three buildings with similar characteristics and construction status- the "Manuel Valle", "José Antonio Echeverría" and "Rubén Martínez Villena" pavilions- , will be carried out through operational reliability tools: Criticality analysis, Impact method and Pareto Technique adjusted for the evaluation of structural, non-structural and plum

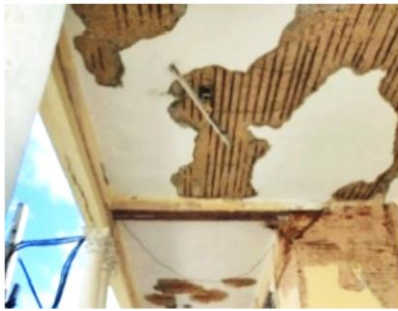
Figure 1. Reinforced concrete slab

The type of foundation existing in the pavilions is unknown, but its evaluation will be carried out taking into account the behavior of the superstructure. The roof of the three pavilions is made with flat concrete slabs reinforced with steel bars, working in one direction (see Figure 1). The beams are made up of two steel I profiles that support bricks until they meet the roof slab on the perimeter of the building and have a depth of 0.50 m. The load-bearing walls were built with ceramic bricks placed citaron. The buildings have two types of columns, circular with a diameter of 0.47 m and square with a side of 0.53 m, in both cases made of reinforced concrete with steel bars and 5.10 m high, as shown in the figure. Figure 2, located in the portals that surround each one of them. building. There are a variety of stairs between the pavilions, but only those that give access to the roof and the main access on the ground floor of these will be analyzed. The Rubén Martínez Villena building has a metal boat staircase and the Manuel Valle and José Antonio Echeverría pavilions have reinforced concrete spiral stairs that allow access to the roof, as shown in Figure 3.

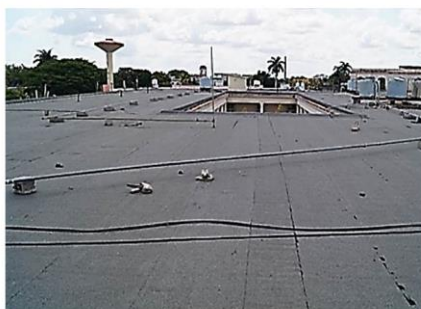
Figure 4. Asphalt blanket with granules

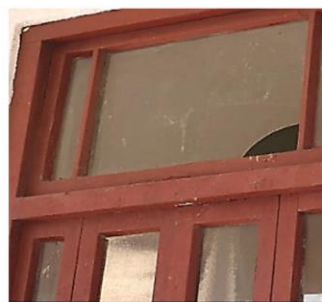
Figure 5. Carpentry

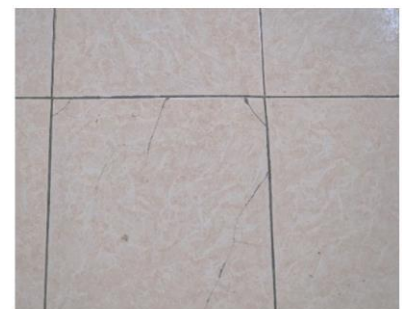
Figure 6. Porcelain tile floors

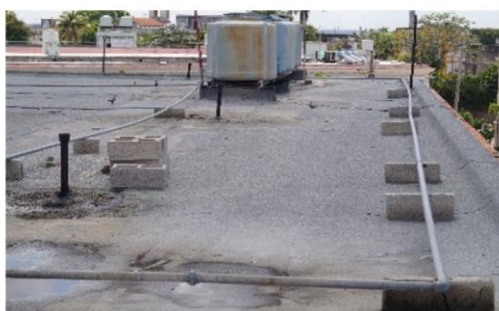
Figure 7. Distributor and elevated tanks

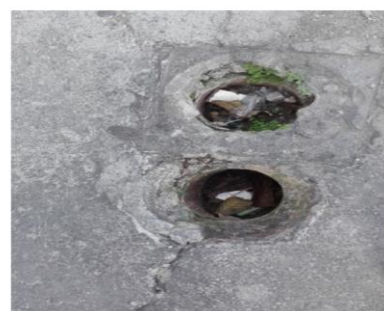
Figure 9. Downspouts

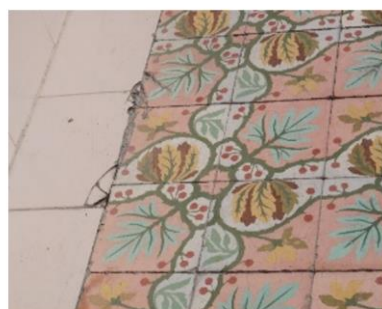
Only one lesion with a high level of criticality was identified in the Rubén Martínez Villena Pavilion, P-04 "Detached, blunt, cracked and/or scratched slabs", belonging to the floor subsystem. As medium criticality, 13 deteriorations appear and 26 are classified with a low level of criticality.

Figure 11. Detached, blunt, cracked and/or scratched tiles

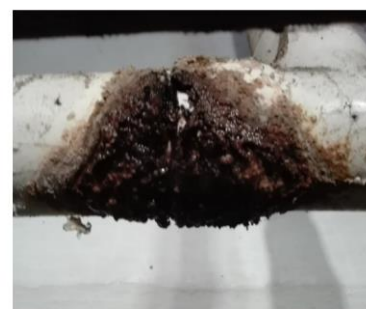
Figure 12. Break in pipes
